TECHNICAL REPORT NO. 332

**The Installation of New Temperature Controllers at Narrabri in
2010 February**

Details of the trip to Narrabri in 2010 February are presented.

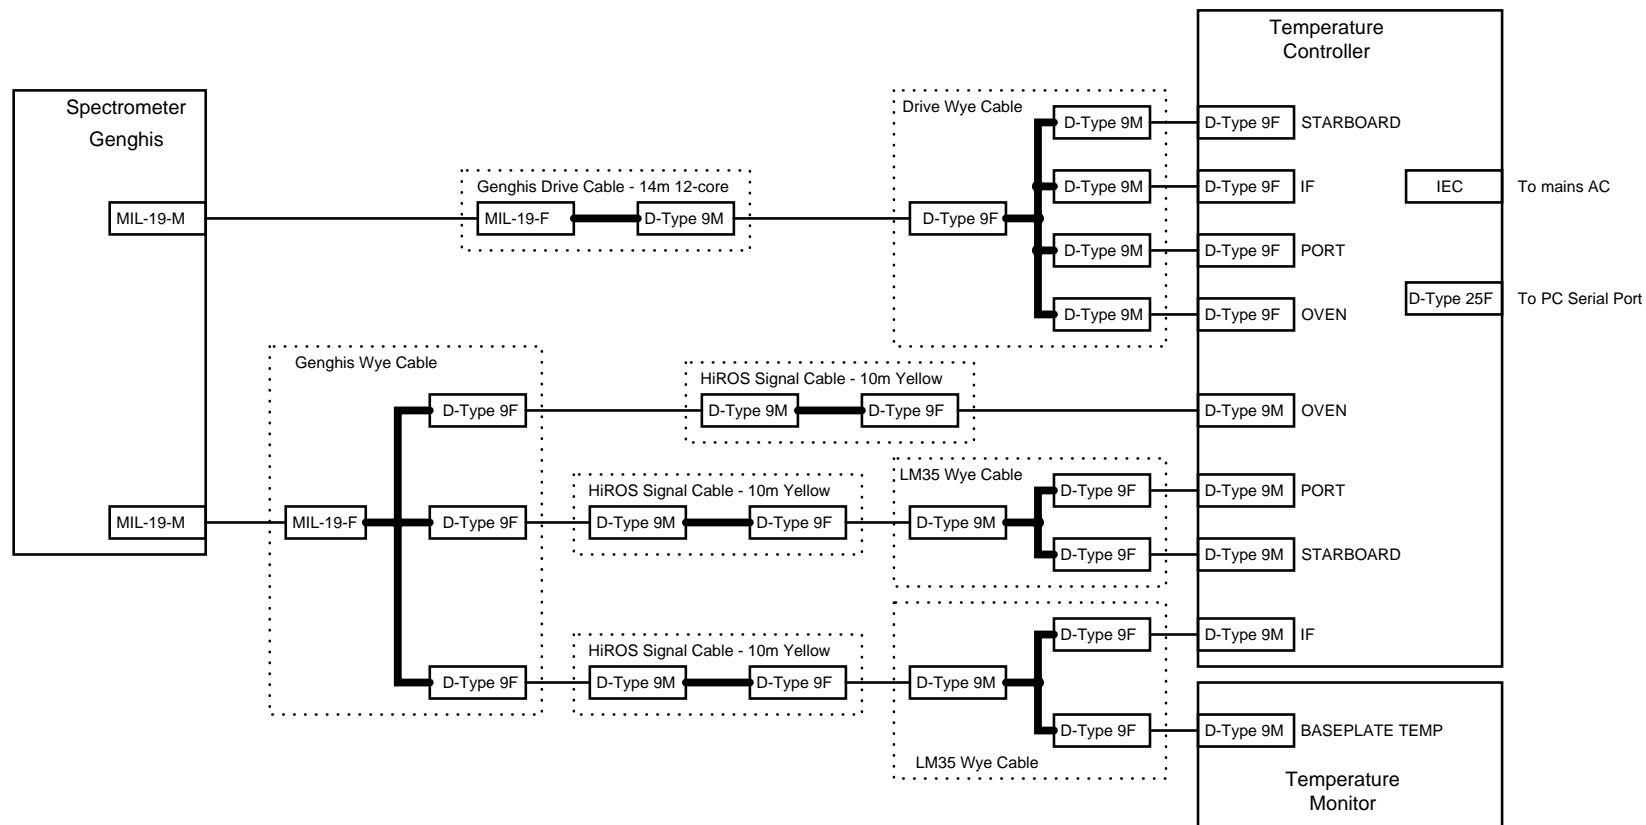
Figure 2: The Narrabri temperature controller system.

During the setup of the temperature controllers it was spotted that the power required to keep the port and starboard detectors at the required set-point of 20°C was very different. By switching off the temperature control and allowing the detection to settle at the ambient temperature, it was found that there was a 1.5°C offset between the two temperature sensors in the detectors. To match the powers required by both detectors, the set point of the port detector was increased to 21.5°C to compensate for the offset.

The power to maintain these setpoints was putting the Peltiers on maximum cool and so the detector temperatures were increased again to 23°C for starboard and 24.5°C for port.

It would be better to apply an offset to the temperature reading for the port detector to make it match the starboard detector, assuming that they are both actually at the same temperature. Unfortunately it is not simple since the temperature controller offset option is applied directly the ADC counts, and not after they have been scaled to temperature.

An offset of -210208 counts was applied to the port detector in *zoo.conf*, and the setpoint of both detectors reset to 23°C . The power required to maintain this temperature was now the same in both detectors.

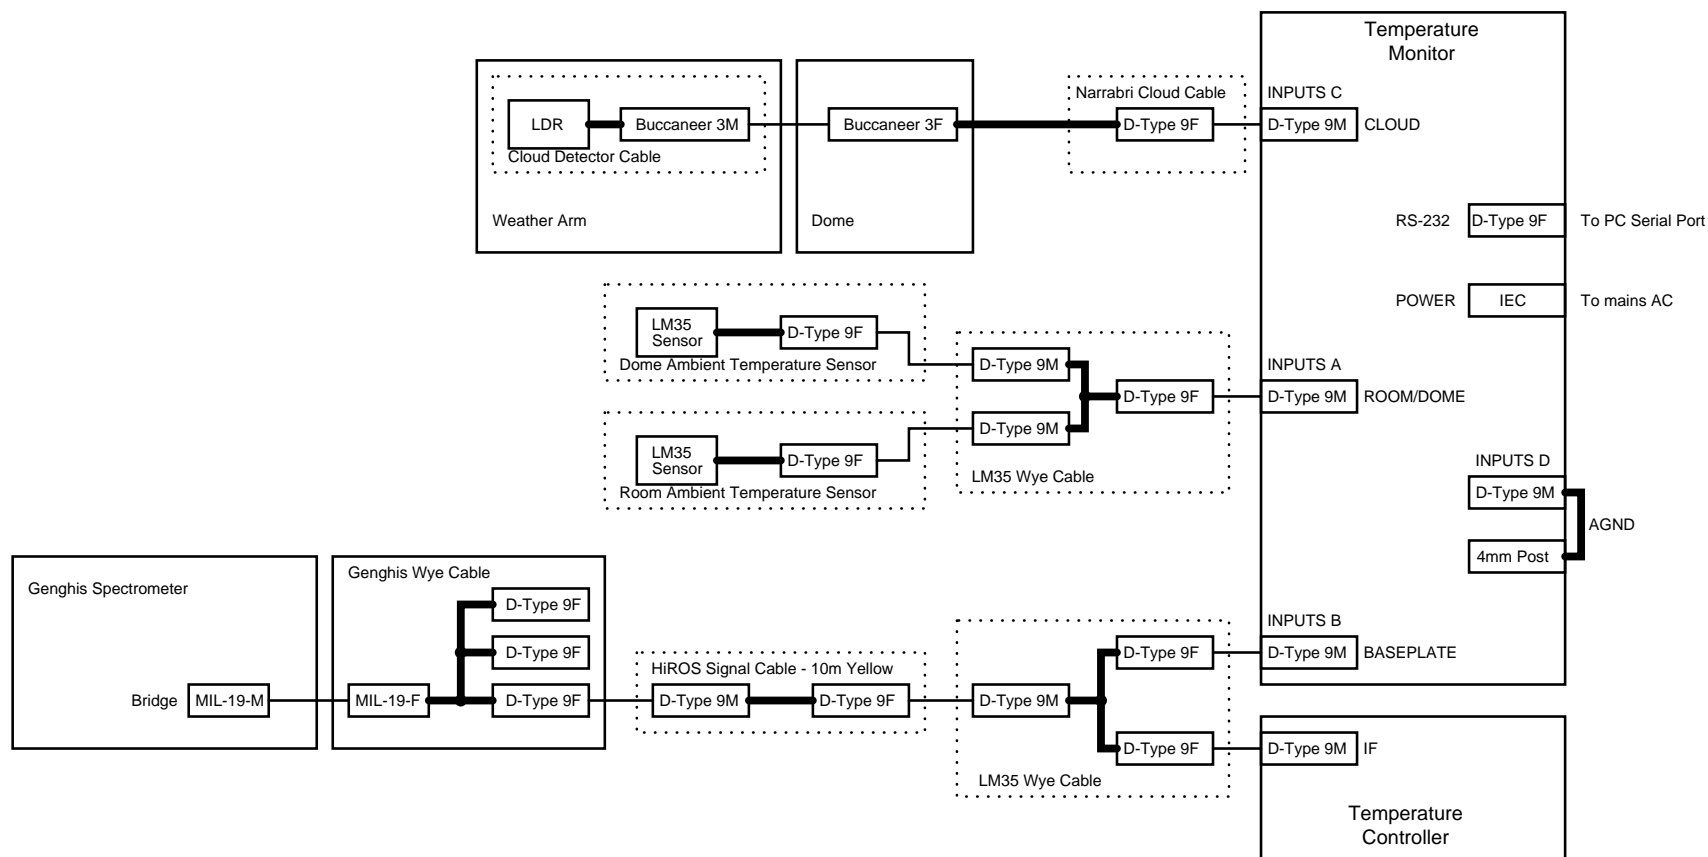
Figure 3: The Narrabri temperature monitor system.

Usually the output from the LM35 sensors is fed into an amplifier stage contained on an LM35 board within the temperature monitor main unit. Unfortunately the Narrabri unit does not have an LM35 board inside it and so the LM35s had to be connected directly to the ADC. This meant a loss of resolution but at least the temperatures could still be measured.

The temperature monitor hardware has undergone several hardware revisions since the Narrabri unit was built. Given the lack of the LM35 board and the fact that the cloud detector interface is on veroboard it is strongly recommended that the temperature monitor here gets replaced on the next visit.

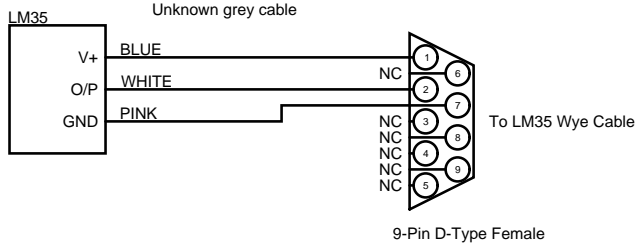
Figure 4: The Narrabri temperature probes.

Also the existing wiring for the LM35 temperature probes was found to be incorrect and used non-standard cable. The probes were re-wired and the wiring is shown in Figure 4.

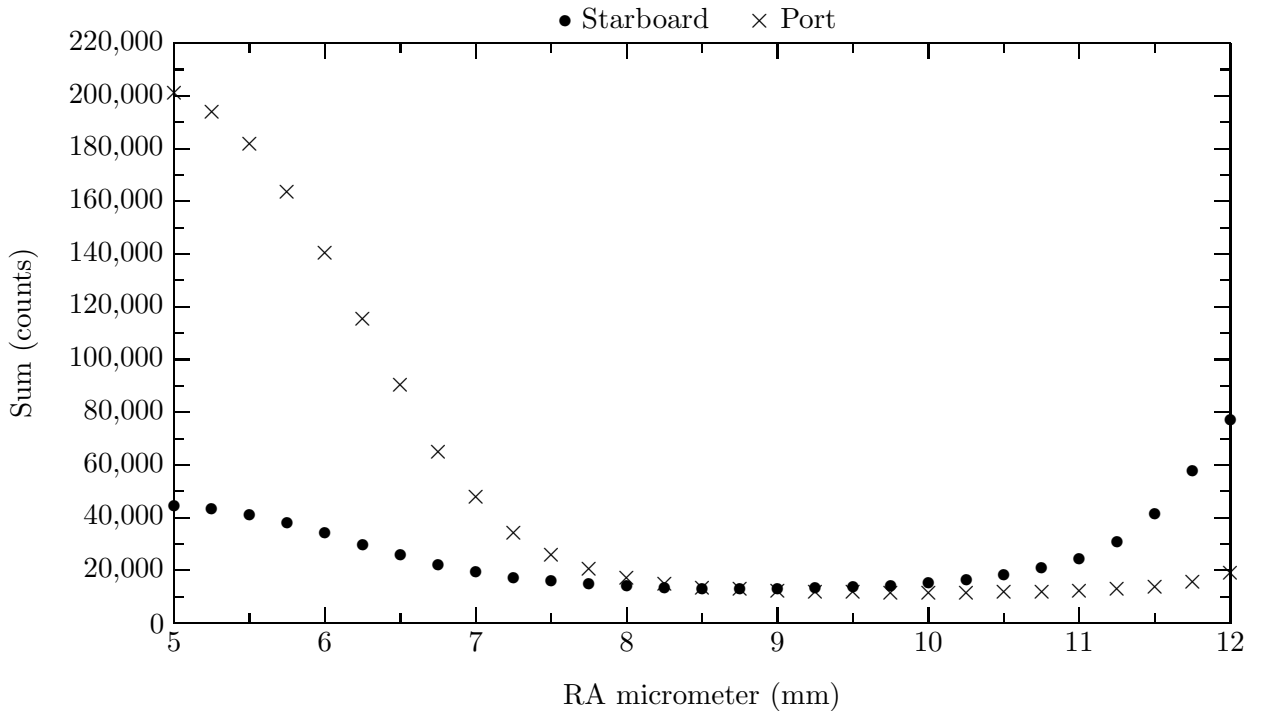
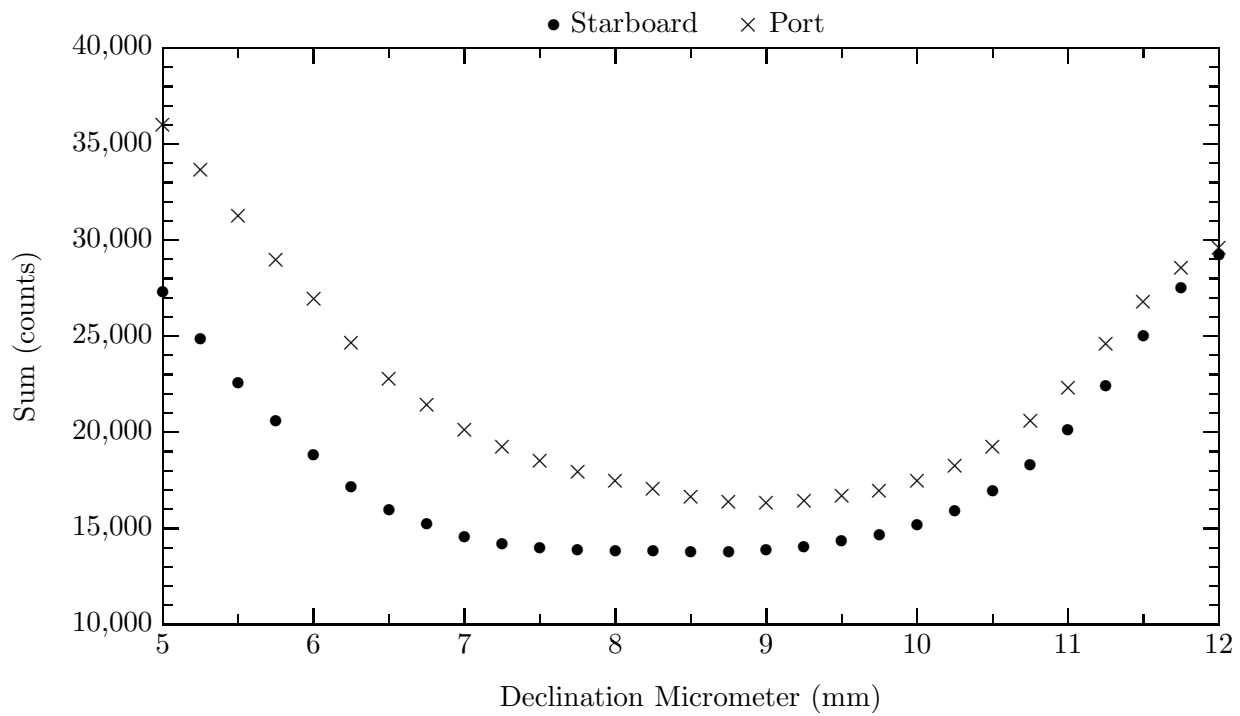
The first scan was done with the oven cold (see Figures 6 and 7). There appears to be some misalignment in RA of the two detectors, since the scan did not suggest the same position for both. A setting of RA = 9.5 mm and Dec = 8.75 mm seemed the most appropriate to minimize the cold scattering.

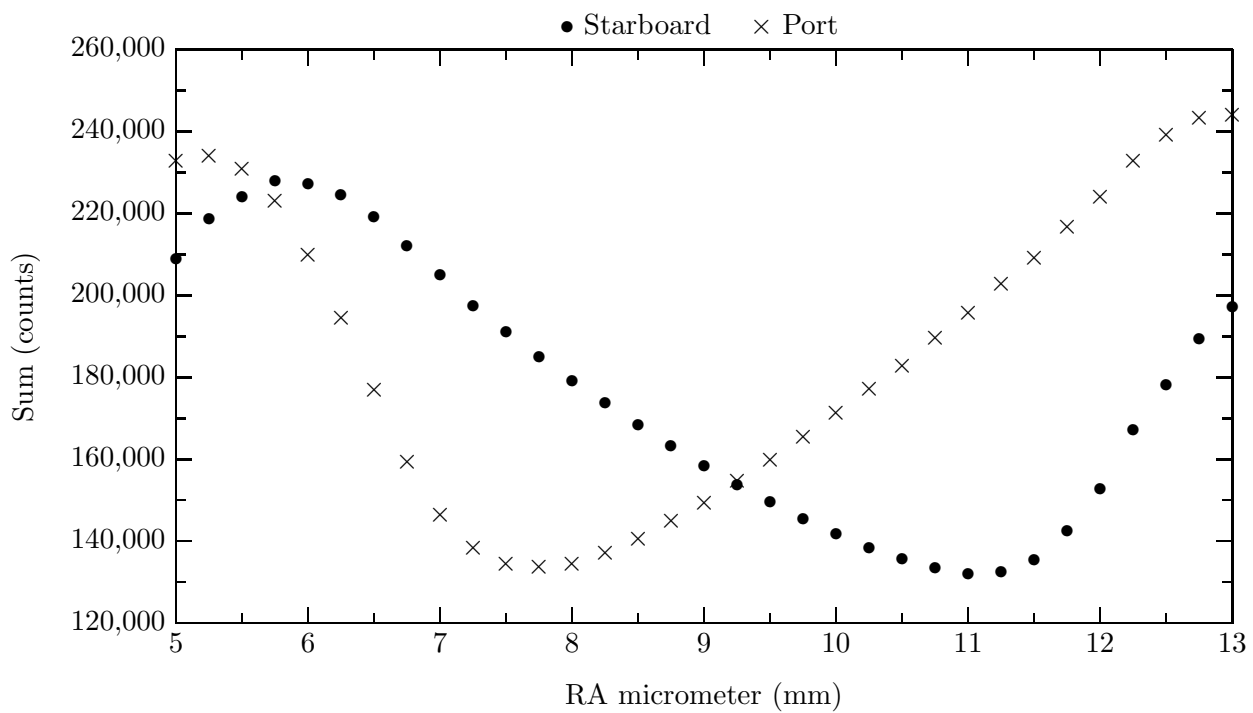
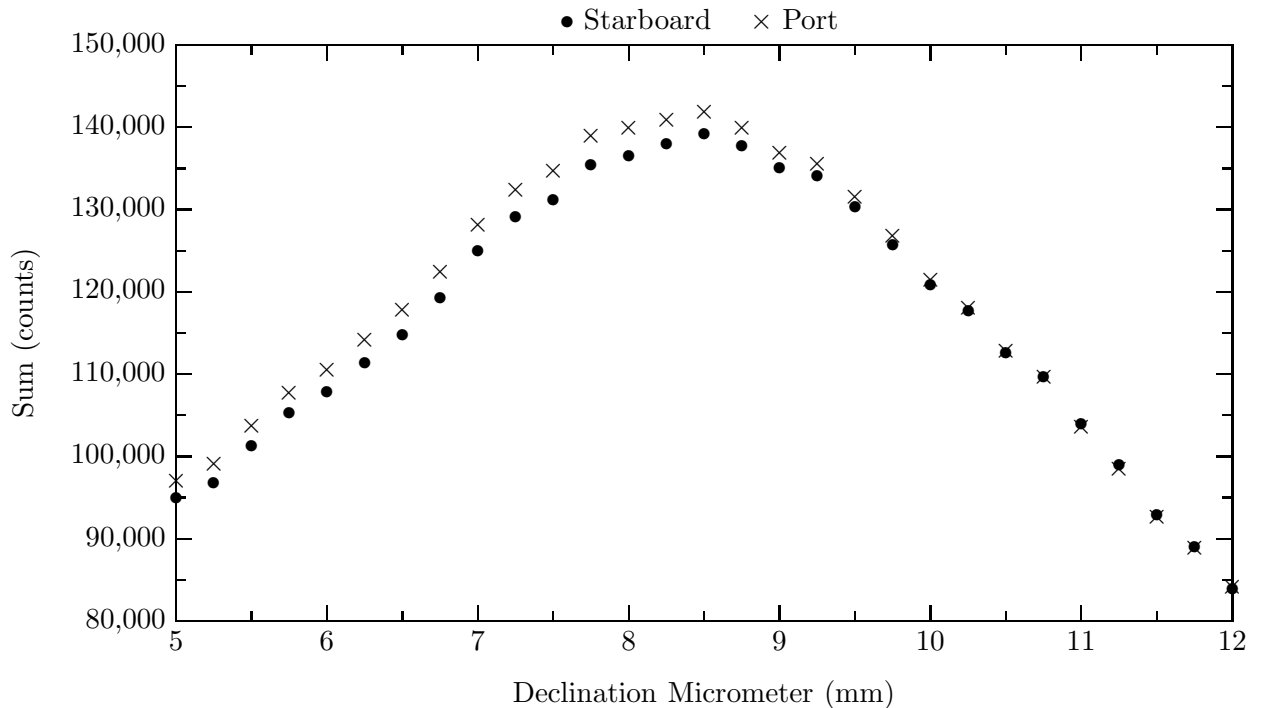
The oven was brought back up to temperature and another scan performed (see Figures 8 and 9). With the cell hot, the misalignment between the two detectors was even more obvious. The best position was chosen to be where the two sums crossed over which was RA = 9.25 mm. The best value for Dec was much more obvious with a clear peak at Dec = 8.5 mm.

So which do we believe? Normally we put more weight on the settings suggested by a cold scan since past experience shows this seems to work better. But with the cold scans being so ambiguous, we decided to leave the guider set at the positions given by the hot scan.

Following the scans the guider was left at RA = 9.1 mm and Dec = 8.5 mm.

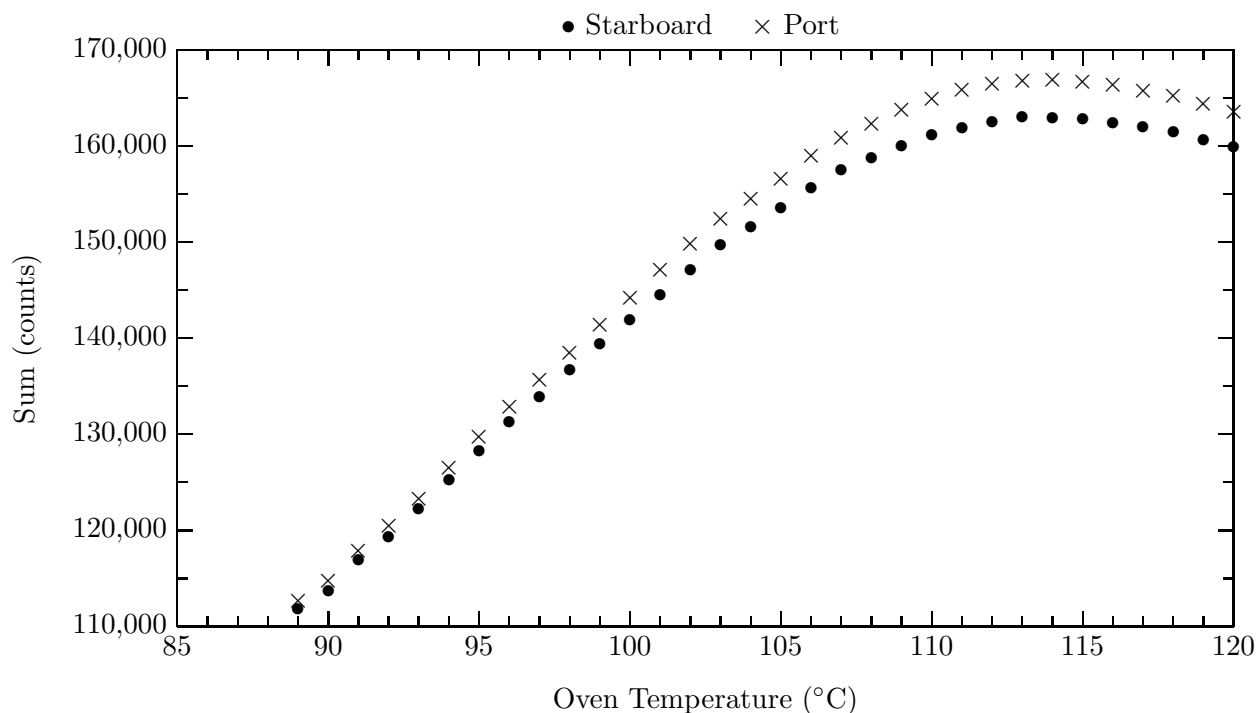
Figure 10: Heating curve (2010 February 16).

On arrival the oven was set to 106°C. After installing the new temperature controllers and optimizing the instrument alignment, a scan was performed on the oven temperature (see Figure 10). The peak was found to be at 113°C and so the oven temperature was increased to this setting.
